# Informational Summary Report of Serious or Near Serious CAL FIRE Injuries, Illnesses and Accidents

## Firefighter Injuries and Fatality

August 13, 2018

Mendocino Complex (Ranch Fire)

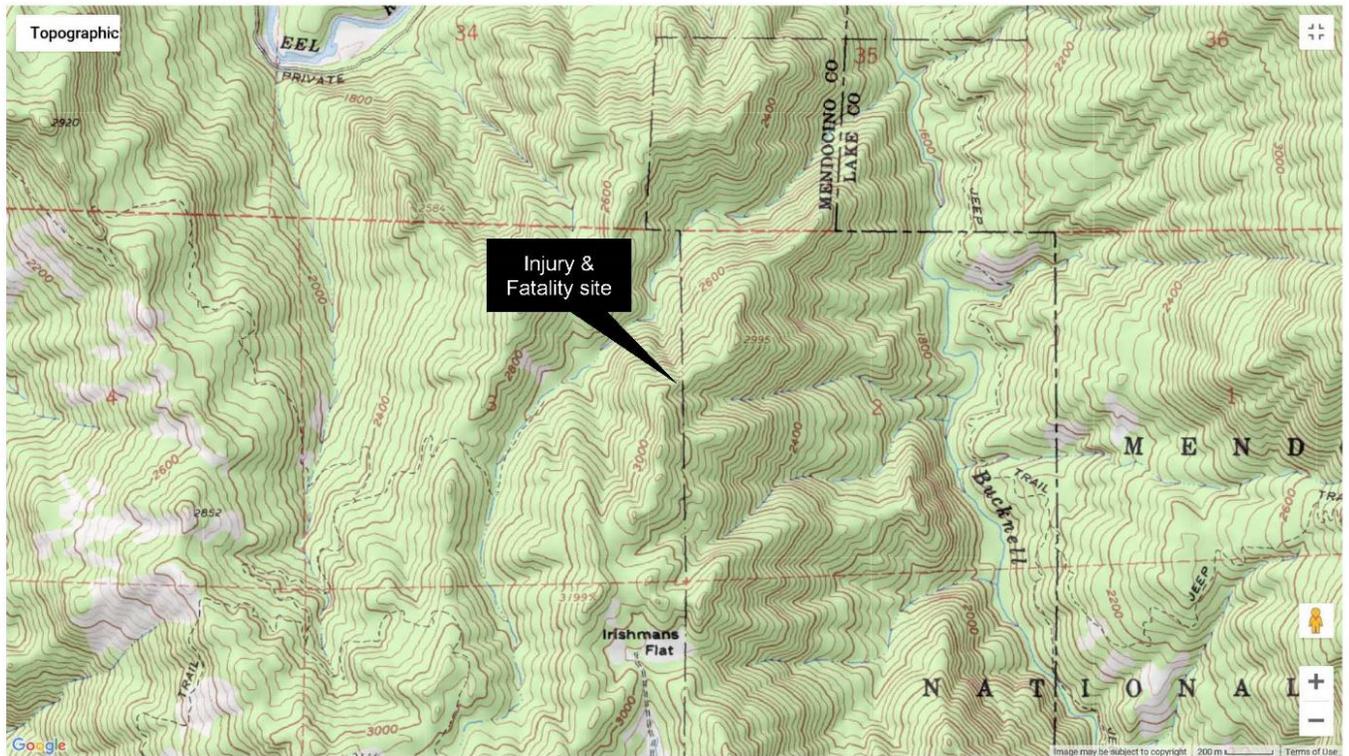
### TOPOGRAPHIC MAP OF ACCIDENT SITE

Approx. Maximum Elevation: 3,363 feet (1,025 meters)  
USGS Topo Map Quad: Potter Valley  
Feature Type: Ridge

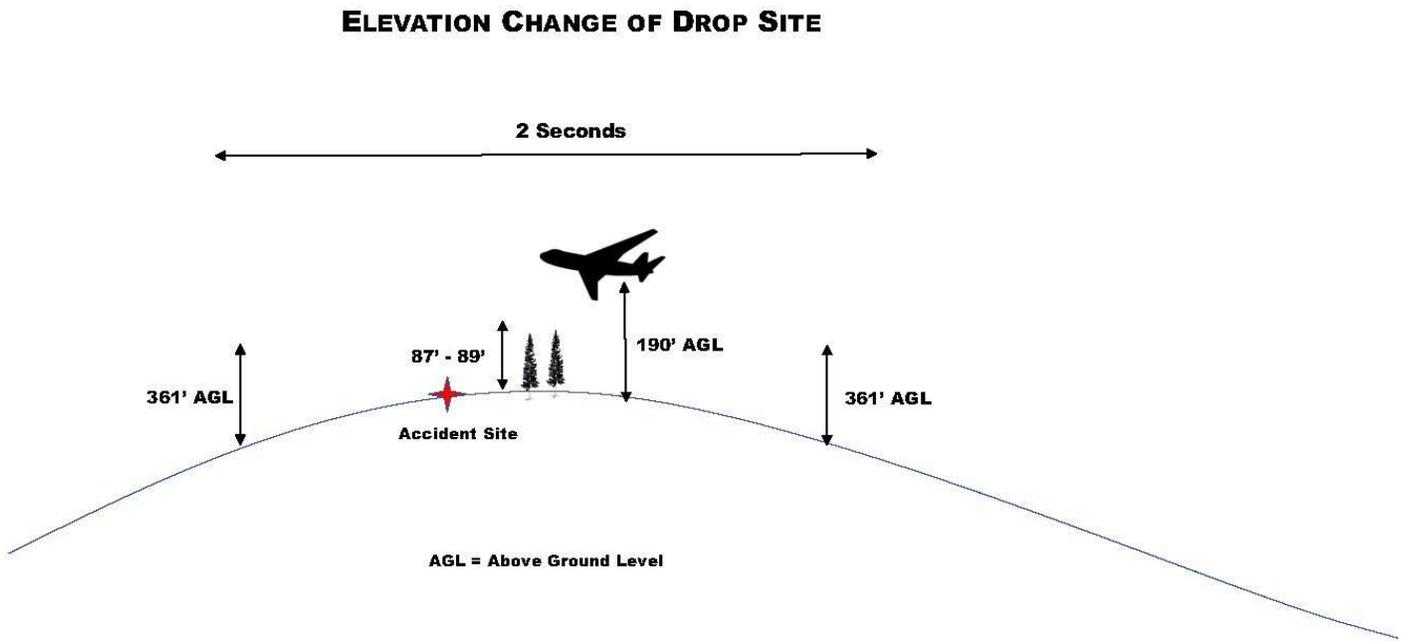
At approximately 5:25 PM, the ASM proceeded on a final approach over the drop path. The ASM identified the drop path to the VLAT by use of a smoke trail. The VLAT initiated the retardant drop as identified by the smoke trail. Obscured by heavy vegetation and unknown to the VLAT pilot, a rise in elevation occurred along the flight path. This rise in elevation resulted in the retardant drop only being approximately 100 feet above the treetops at the accident site.

Elevation change during retardant drop

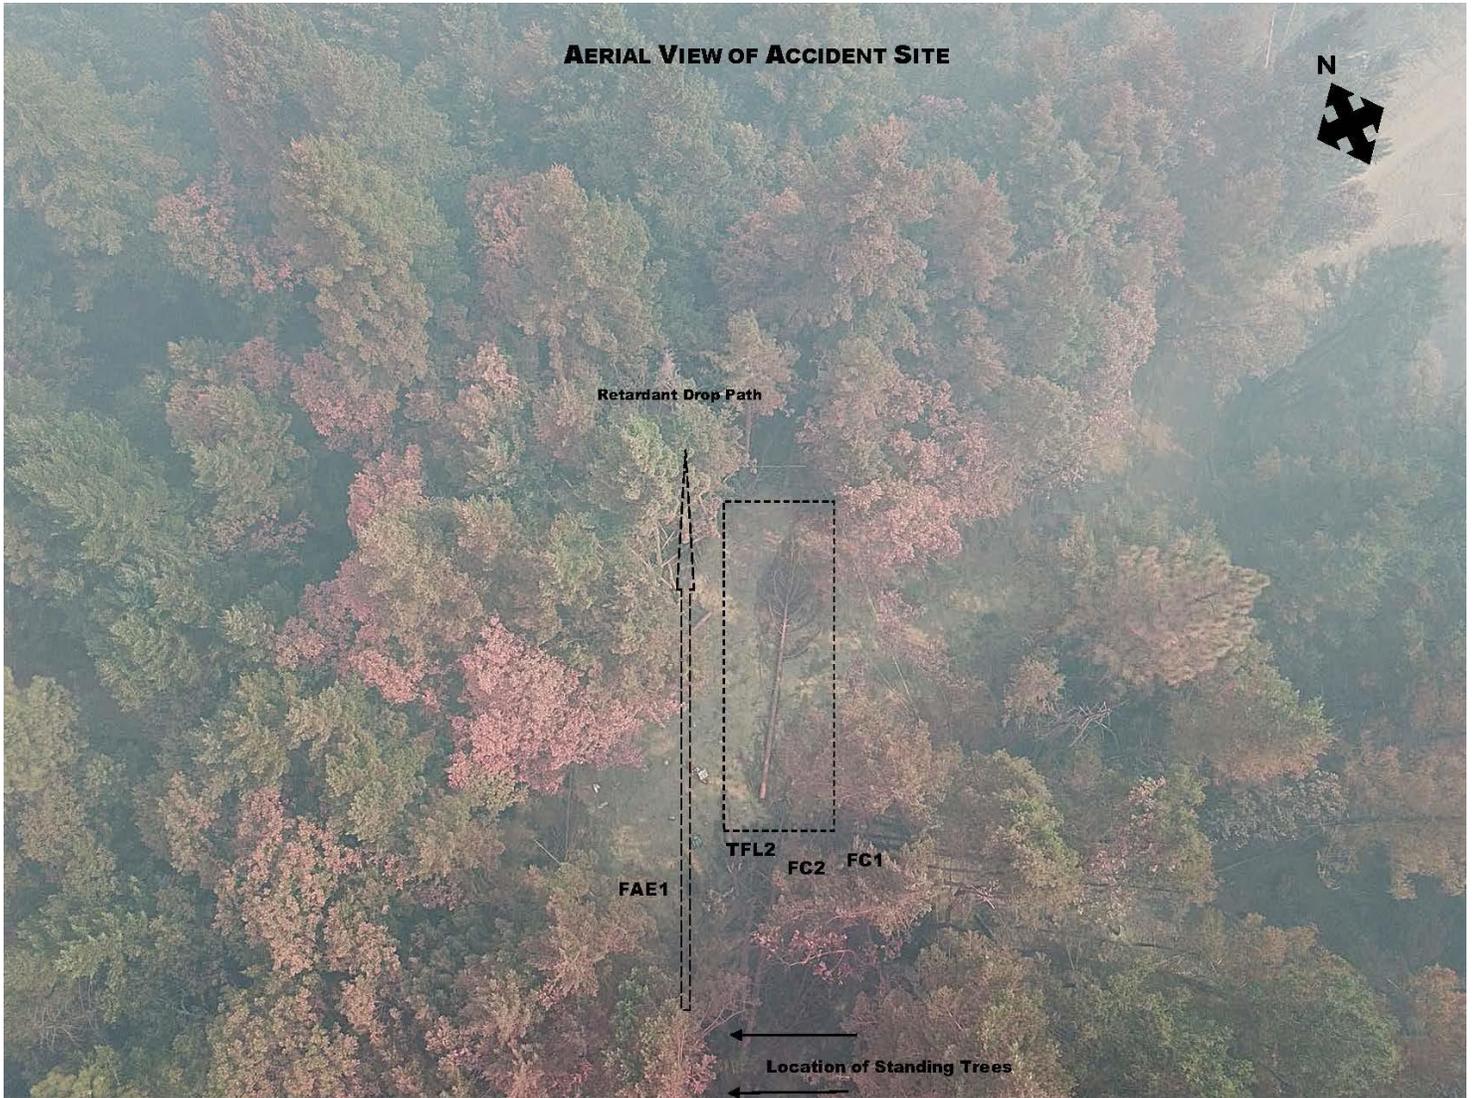
The force of the retardant drop uprooted an 87-foot tall Douglas Fir with a 15-inch diameter at breast height (DBH). It fell on TFL2 and caused fatal injuries. The drop also sheared an 89-foot tall, 18-inch DBH Douglas Fir 29 feet above the base. The debris hit FC2 and caused extremity injuries and broken ribs. FC1 and FAE1 were struck by falling branches of the trees causing moderate injuries to FC1 and FAE1.

Aerial view of accident site

- Aerial drops are inherently hazardous and caution should be used when working in areas with aircraft operations.
- Supervisors must ensure all fire line personnel are notified and acknowledge impending aerial drops (fixed wing and rotary wing). When personnel are working under a tree canopy, supervisors must ensure the drop path is cleared.
- Fire personnel need to always maintain situational awareness.
